## Test Report

No. SZXEC1900278308

SHENZHEN DERUI ELECTRONIC CO., LTD

The following sample(s) was/were submitted and identified on behalf of the clients as : LCP black

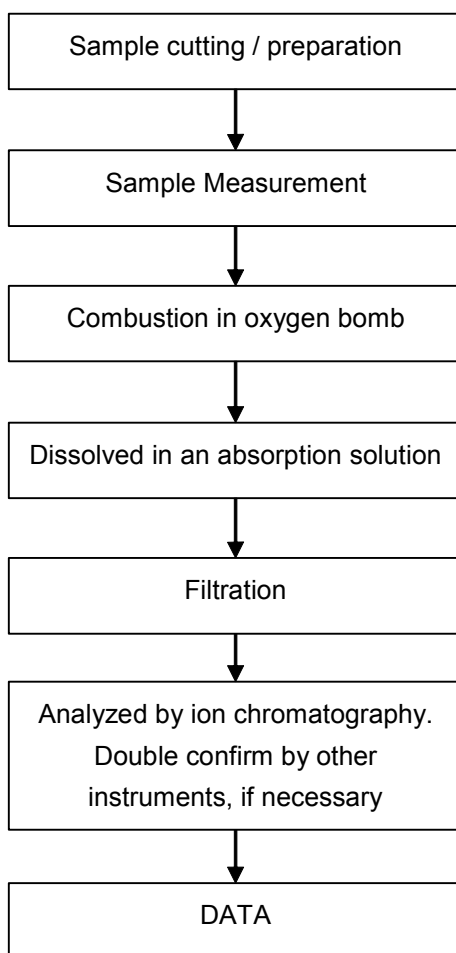
### Halogen Testing Flow Chart

Test Method : With reference to EN 14582:2016, analysis was performed by IC.
